# Assessment of the remaining service life of Curado walkway and the bridge over the River Tanque, Pernambuco, Brazil

**ABSTRACT:** This study addresses the assessment of the Curado walkway and bridge over the River Tanque, both situated on the federal highway BR-232/PE, using the service life concept of standard ISO 15686 (2011) and the performance precepts of standard ABNT NBR 15575-1 (2013). The existing guidelines for inspection procedures and to assess the stability conditions of these structures in standard DNIT 010/2004-PRO were adopted. The results highlight the use of this methodology to estimate service life in case studies where there is no background of regular inspections.

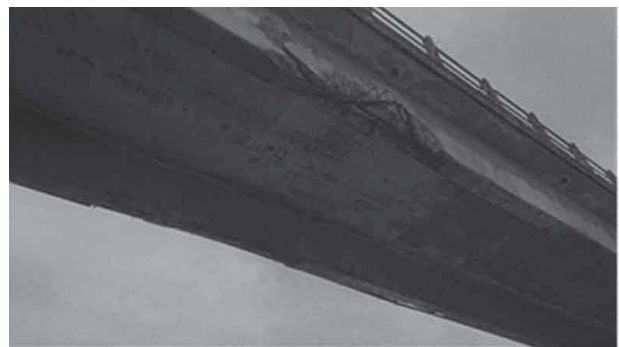
With regard to the walkway's stability, special should shall be given to the deck, considering that two stringers of the central walkway have reinforcement bars (Figure 6) and shearing partly destroyed by impact of vehicles traveling along the highway with a vertical clearance beyond the standard recommendation (5.5 m).

Figure 6. Stringers in the central walkway containing reinforcement bars and shearing partly destroyed by vehicle impact.

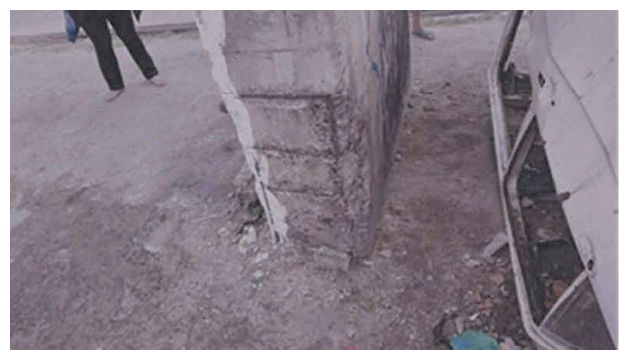
Different corrosion processes were identified in the reinforcement bars at the base of some of the structure's pillars (Figure 7).

Figure 7. Corrosion of reinforcements at the bottom of one lateral pillar surface of the structure.

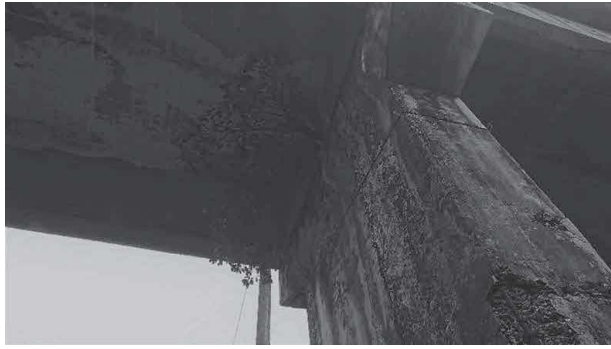
Also regarding the walkway, some fair-sized plants were seen in the deck joints and concrete showing efflorescence and moisture (Figure 8).

Figure 8. Presence of sparse vegetation, general seepage, efflorescence and corrosion of reinforcement on one side of the walkway's pillar.

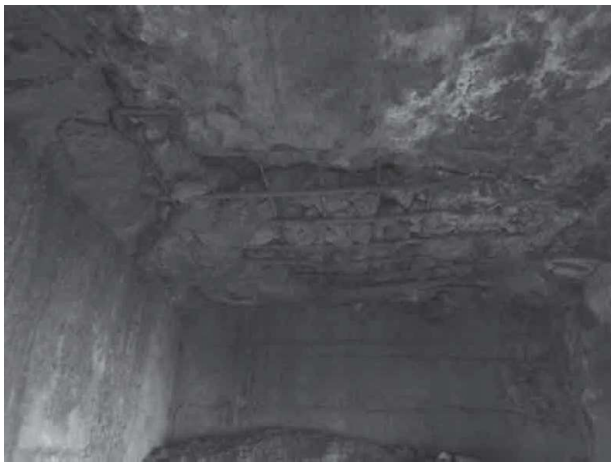
In this respect, major deterioration was found in the lower part of the deck. Figure 9 shows holes in the concreting and efflorescence.

Figure 9. Severe deterioration of the bottom part of the deck due to the presence of holes in the concrete and efflorescence.

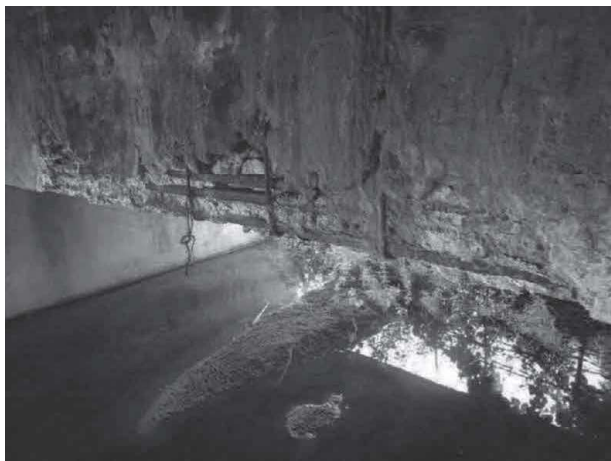
With regard to the stringers, Figure 10 portrays the severe corrosion of reinforcement bars in one of these structural elements.

Figure 10. Severely corroded reinforcement bars in one of the bridge stringers.

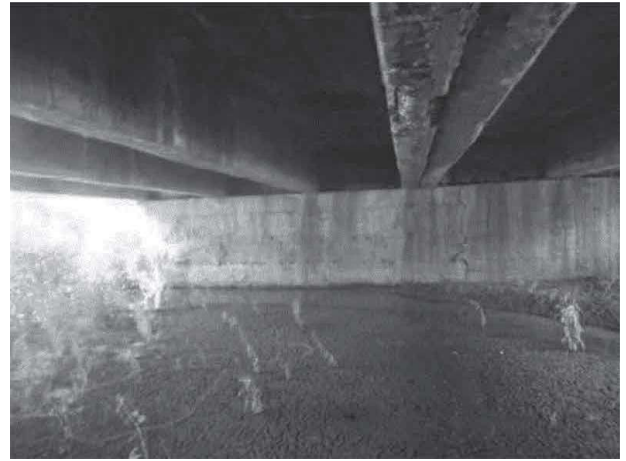
Subsidence was also observed in one of the traffic lanes as a result of widening without consolidation (fixed support) in the old structure. Figures 11 and 12 highlight the aforementioned widening and subsidence.

Figure 11. Widening without consolidating the old structure.

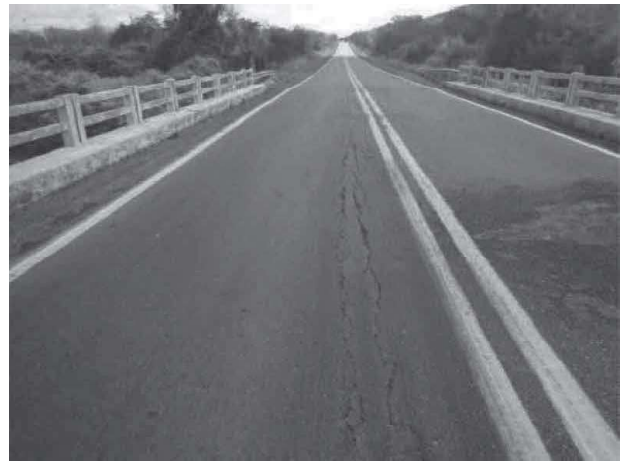
Figure 12. Subsidence in a traffic lane on the bridge.
