CONSEC  
2019

***Study on the current conditions of a bridge exposed to an aggressive environment on  
highway BR-101 / PE***

It is in this context that this paper shows the study of the Igarassu River's Bridge, on highway BR 101 / PE, km 41.7 subject to severe environmental conditions, heavy traffic and no maintenance.

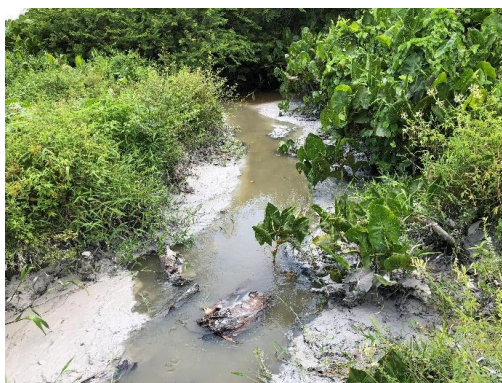
For many years this bridge is in advanced state of structural deterioration, partly caused by the aging process of the structure, aggravated by the fact that it is located in an area of high environmental aggressiveness and receives under its structure polluting waste from a factory, resulting from the process of manufacturing toilet paper, napkins, paper towels and cartons, as shown in Figure (3).

**Fig. 3: Waste pollutants that flow into the river under the bridge**

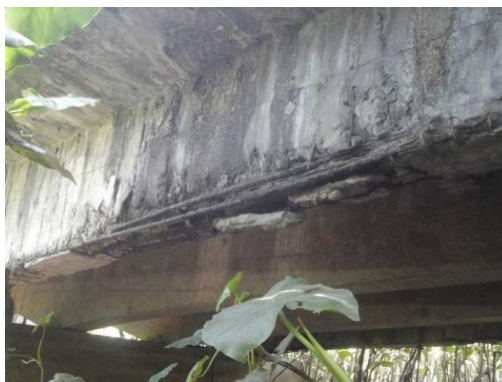
The problems identified in the superstructure are those that represent a higher risk and are related to the advanced state of degradation of concrete and reinforcements of girders, especially those located at both edge of the abutments. The two internal beams also have concrete and rebar damaged, but with less severe deterioration.

The structural insufficiency of the external beams is characterized by significant losses of the sections of the bending and shear reinforcement, associated to the loss of adhesion between these reinforcements and the concrete. The concrete in turn shows itself in an advanced state of deterioration, as shown in Figures (4) and (5).

**Fig. 4: Loss of concrete sections and bending rebar in external girders**

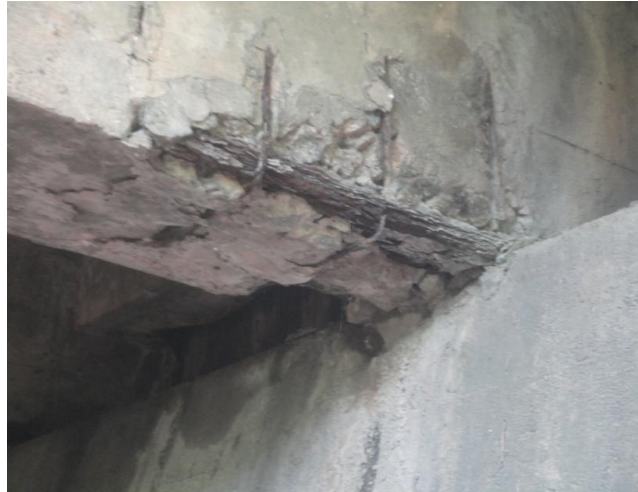
**Fig. 5: Severe corrosion and destruction of shear reinforcement in regions of the external beams support**

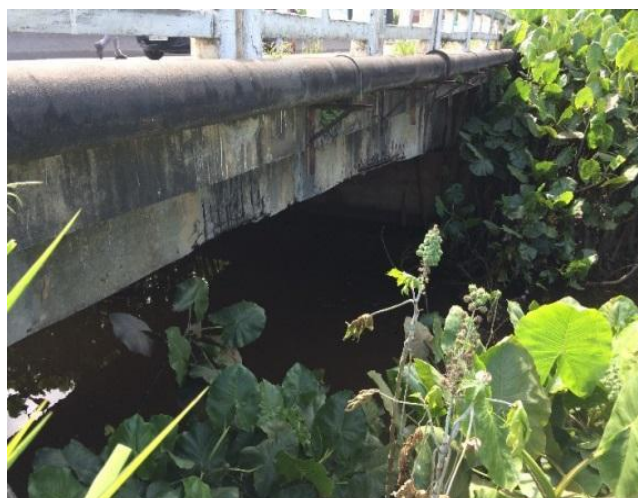
The cross beams and the lower surface of the slab of the bridge also show a constantly evolving degree of deterioration, characterized by exposed and oxidized reinforcement, efflorescence from the leaching process and cracks in the concrete. It is possible to observe large infiltrations of water by the edge joints, by the porous concrete itself of the bridge deck and also by the absence of drains and drippings at the ends of the lateral balances of the slab of the bridge deck. Another issue observed was the undue fixing of pipes on the sides of the deck, which also contributed to aggravate the damages and infiltration of water in the concrete. These problems are illustrated in Figures (6) and (7).

**Fig. 6: Inadequate mounting of pipes on deck, increasing the damages on the concrete**

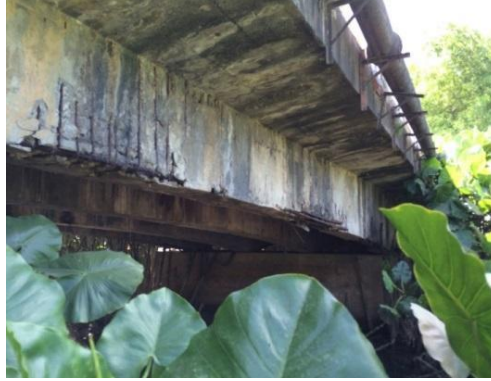
**Fig. 7: Infiltrations, efflorescence and generalized staining on the lower surfaces of the deck**

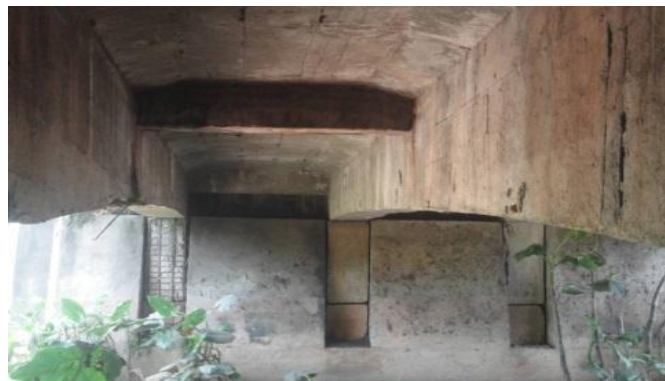
The mesostructure, consisting of two abutments and a concrete pillar-wall, receives the loads from the bridge deck through pendulum type bearings at one end and metal bearings at the opposite end and at the central support. The observations made during the inspections showed that there are major failures in the concrete pendulums and a destruction of the metal bearings. This means that these elements are no longer conveying the forces nor allowing the movements of the structure as predicted in the original design of the bridge. In general, both abutments and the central pillar, although showing some deterioration, have no significant damages; however, the bearings are no longer fulfilling their functions, especially in the case of the pendulums, where it is observed the possibility of at least one of them reaching the rupture. As for the metal bearings, it is possible to observe the crushing of the concrete of the beams in the region of compression on the supports. These situations can be seen in Figures (8) and (9).

**Fig. 8: Collapse of one of the pendulums type bearings one of the girders.**

It has also been observed that the bearings show a worrying situation because of the importance of these elements in the transmission of the forces of the bridge deck for the abutments and pillars, especially the pendulum that acts as support of one of the external girders, badly damaged and in a pre-collapse state. The other bearings, probably in lead plates, are completely crushed and no longer fulfill their functions.

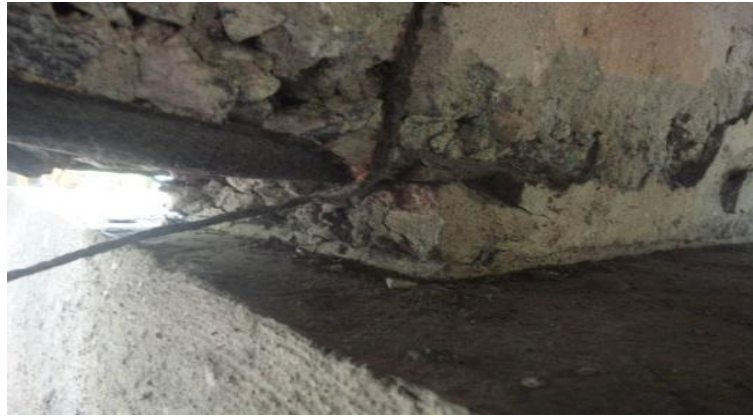
**Fig. 9: Crushing of the concrete and bearings of one of the beams**
